Manhole Inspection Summary

Manhole # S43SS_006MH

Insp Date: **2/22/07 9:00 AM**

Location Address: **1709 CARSWELL ST**

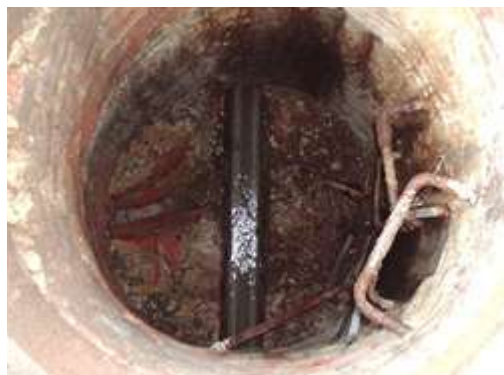
Top View

Corroded steps. Evidence of surcharge - Bench debris.

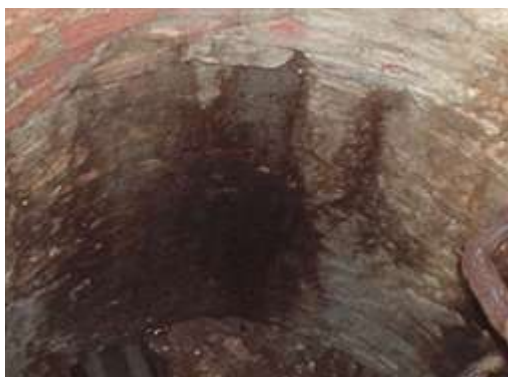
Defect

Barrel deterioration and infiltration.

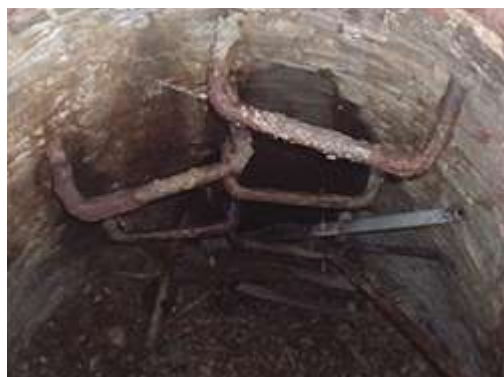
Defect

Barrel infiltration. Bench debris.

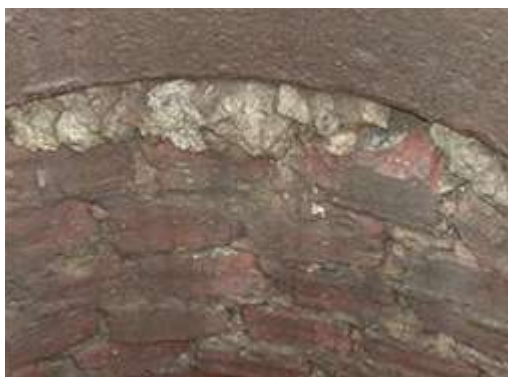
Defect

Frame leaks. Adjustment and Corbel deterioration and infiltration.

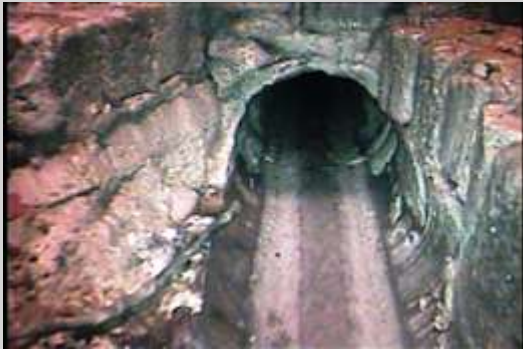
8 in. Circular Gravity Sewer Pipe Out @ 12 O'Clock

Channel deterioration.

Infiltration: **Evidence** Pipe Seal Cond: **Cracked**

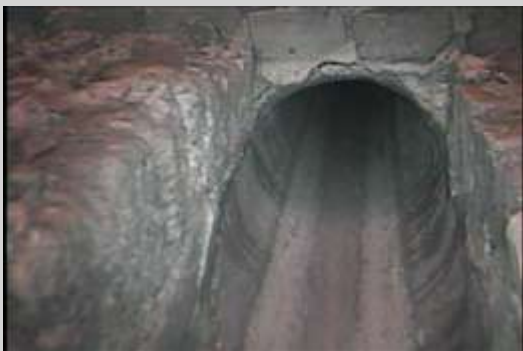
8 in. Circular Gravity Sewer Pipe In @ 6 O'Clock

Infiltration: **Evidence** Pipe Seal Cond: **Cracked**

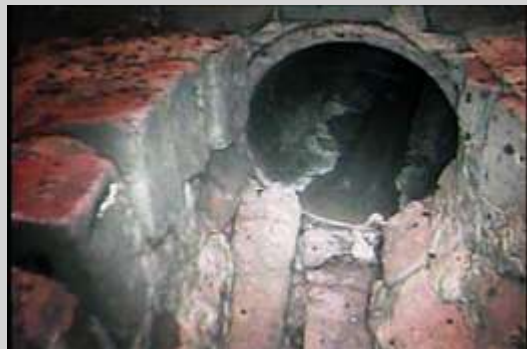
Pipe In @ 9 O'Clock

Bench and Channel deterioration.
